HISTORIC AMERICAN ENGINEERING RECORD

INDEX TO PHOTOGRAPHS

TREMONT STATION BRIDGE

(N.Y.N.H.&H.R.R. Boston-Provincetown Bridge No. 45.38)

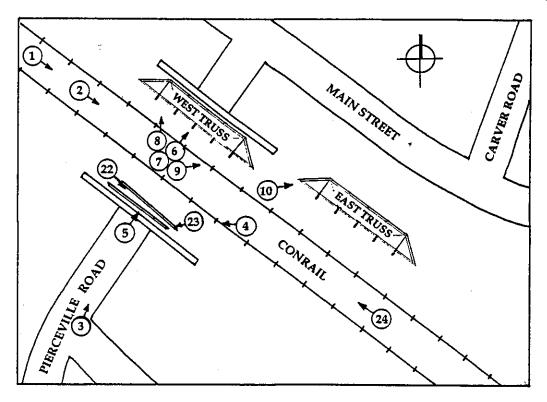
KEY TO PHOTOGRAPHS TREMONT STATION BRIDGE (N.Y.N.H.&H.R.R. Boston-Provincetown Bridge No. 45.38) (Pierceville Road Bridge) HAER No. MA-141 (page 3)

WEST TRUSS DETAILS

EAST TRUSS DETAILS
